UPDATED SEPTEMBER 2020

# City of Frontenac West End Subdivision Street Evaluation Summary Report

Lochmueller Group  
411 N. 10<sup>th</sup> Street, Suite 200  
St. Louis, MO 63101  
314.621.3395  
Project No: 518-0090-OHY

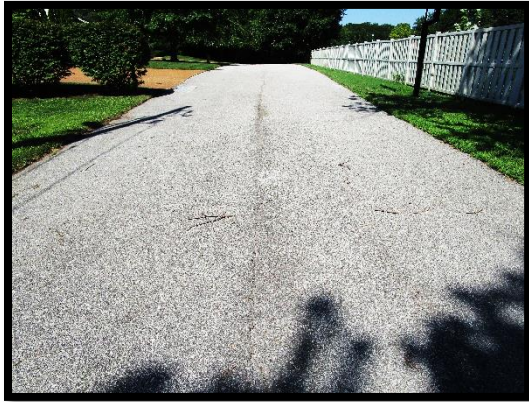
Donoho Place:  
Longitudinal & Transverse Cracking

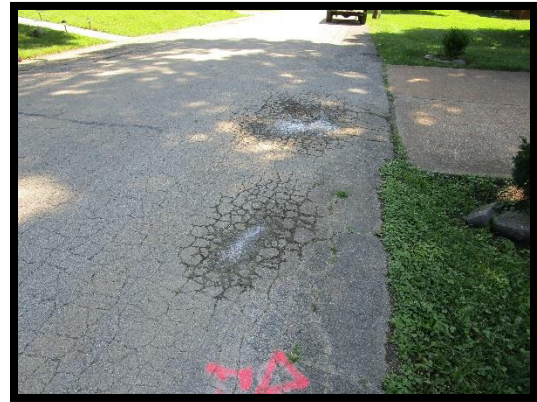
Garibaldi Place:  
Alligator Cracking w/ Potholes

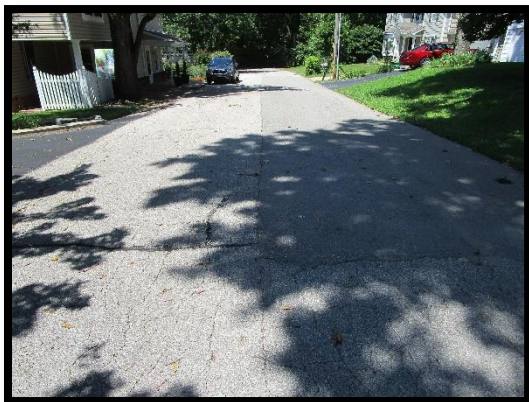
Savannah Avenue:  
Longitudinal & Transverse Cracking w/  
Alligator Cracking

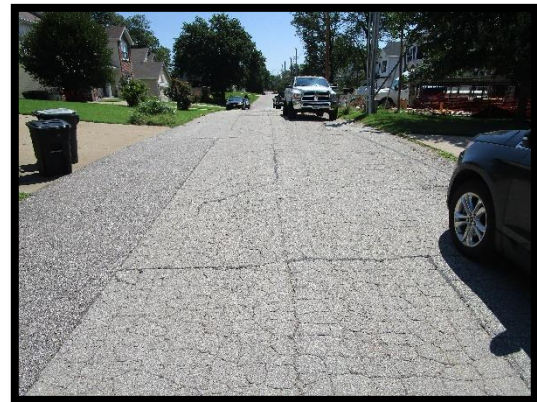
Anzieger Avenue:  
Longitudinal & Transverse Cracking w/  
Alligator Cracking

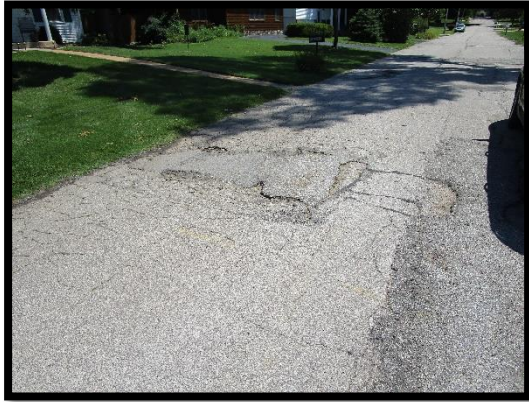
Arthur Place:  
Longitudinal & Transverse Cracking,  
Alligator Cracking, Raveling, & Potholes

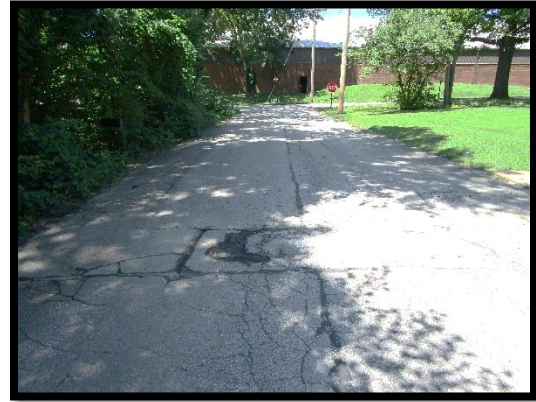
Cable Avenue:  
Longitudinal & Transverse Cracking,  
Alligator Cracking, Raveling, & Potholes

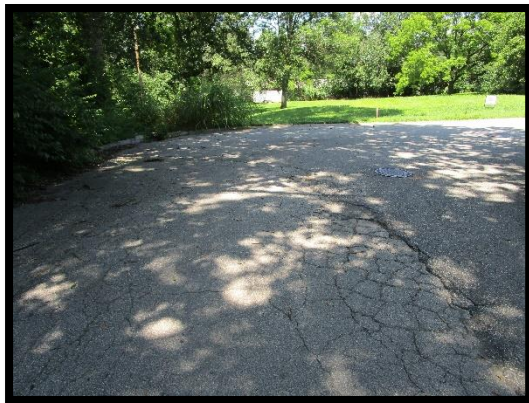
Princess Avenue:  
Longitudinal & Transverse Cracking,  
Alligator Cracking, & Raveling

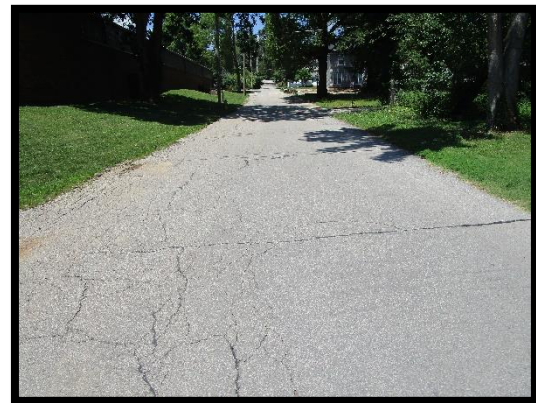
Dwyer Avenue:  
Transverse Cracking, Alligator Cracking, &  
Raveling
